Manhole Inspection Summary

Manhole # S29E__018MH

Insp Date: **1/20/09 11:30 AM**

Location Address: **210 N.Pine St.**

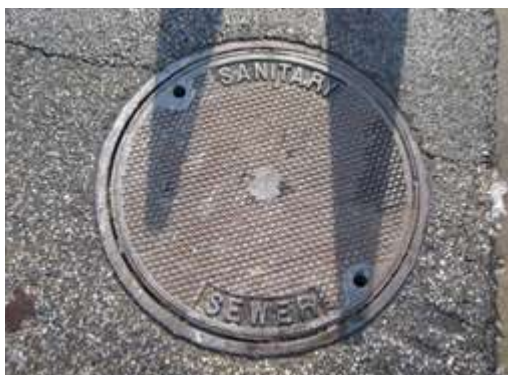
Miscellaneous

MH Lid

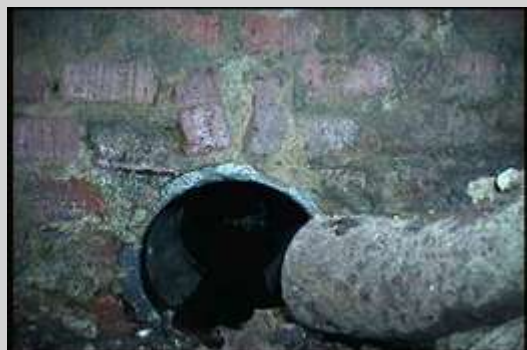
12 O'Clock Outflow

8 in. Circular Gravity Sewer
Pipe Out @ 12 O'Clock

Pipe Height: **8.4** (in.) Rod and Bar (Angled)

Pipe Material: **Clay** ☐ Pipe Lined

Infiltration: **None** Pipe Seal Cond: **Sound**
